Manhole Inspection Summary

Manhole # S13UU_008MH

Insp Date: **8/6/07 12:03 PM**

Location Address: **WABASH AVE**

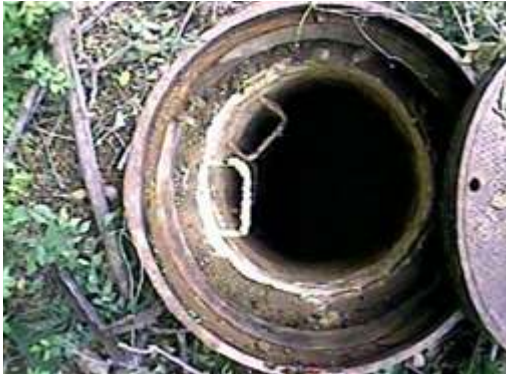
Defect 1

Offset: **4** (in.)

OFFSET FRAME

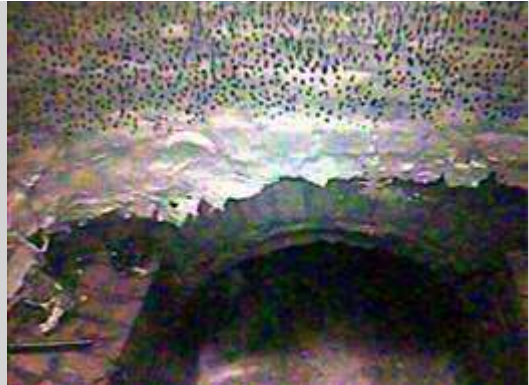
12 O'Clock Outflow

24 in. Circular Gravity Sewer
Pipe Out @ 12 O'Clock

Pipe Height: (in.) Direct
Pipe Material: **PVC** ☐ Pipe Lined
Invert Depth: **23.82** (ft.) Flow Characteristics: **Turbulent**
Deposits: ☒ None ☐ Mud ☐ Sludge ☐ Debris ☐ Grease
Silt Depth: (in.) Deposits Extent:
Infiltration: **None** Pipe Seal Cond: **Sound**

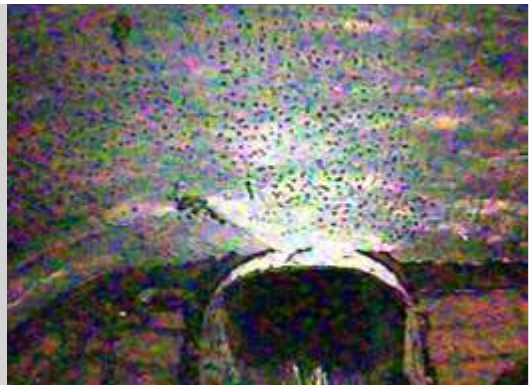
5 O'Clock Inflow

15 in. Circular Gravity Sewer
Pipe In @ 5 O'Clock

Pipe Height: (in.) Direct
Pipe Material: **PVC** ☐ Pipe Lined
Invert Depth: **23.15** (ft.) Flow Characteristics: **Turbulent**
Deposits: ☒ None ☐ Mud ☐ Sludge ☐ Debris ☐ Grease
Silt Depth: (in.) Deposits Extent:
Infiltration: **None** Pipe Seal Cond: **Sound**

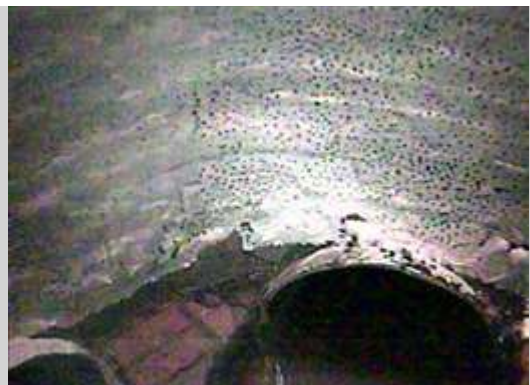
7 O'Clock Inflow

24 in. Circular Gravity Sewer
Pipe In @ 7 O'Clock

Infiltration: **None** Pipe Seal Cond: **Sound**
